Inoperable or Sticky button

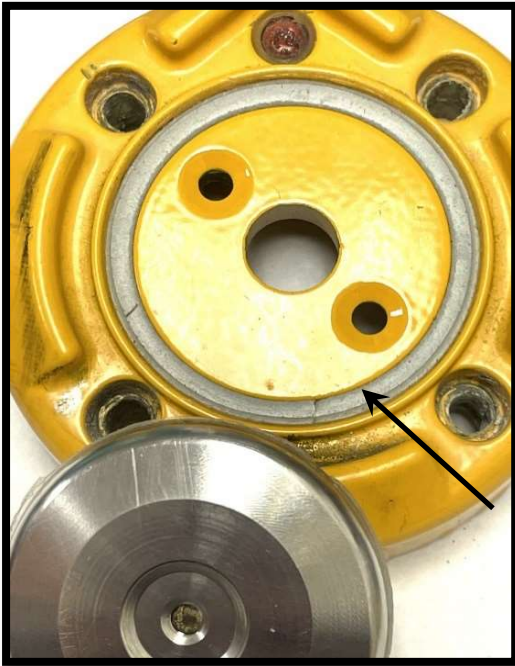
This season we came across a unit where heating the silver dome did not work. We replaced the button with a new one and took the one we removed back to the workshop to troubleshoot the issue. When the dome was removed we did find some moisture on the back of the dome and recessed deck behind it. Further, we also noticed moisture on the recessed foam ring in the recessed deck. I might add, the workshop is not heated, so this eliminates condensation forming as a cold object is brought into a moist warm area.

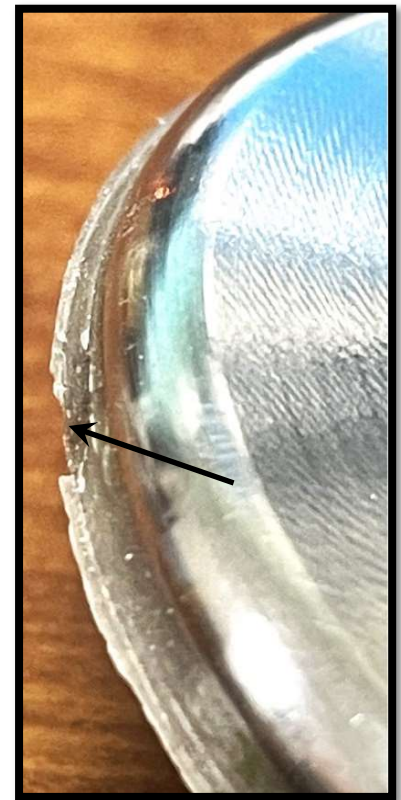
There is very little room between the outer circumference of the silver dome and the recessed deck of the body of the Bull Dog. When we removed the silver dome we did notice a very thin line of what looks like silicon around it. It is expected this is / was acting similar to a gasket. Closer inspection to the silicon we could see some irregularity to its uniformity - this could have been damage from

when we disassembled the unit. Or this maybe this is how moisture was able to get in.

I called the manufacture and explained what I thought was happening. Being robust, I suggested these would be a great candidate to be refurbished instead of discarding. They were kind enough to search through their assembly drawings and confirm it was an exterior GE Silicone used.

The refurbishing starts with a thorough cleaning of all surfaces were the silicon will be applied. We seen silicon also on the outer raised rim of the grey foam ring and found a ring of silicon between the bull dog body and the epoxy electronics. We got a small tube of GE Silicon, the 83ml tube size. A tiny hole was made in the nozzle so it was easier to direct the silicon where it was needed.

The Bull Dog now assembled, the GE Silicon applied, then set a side to allow it to cure. This Bull Dog will be place back into service from where it was removed.
