Impacts To The Poles Can Cause SRRFB Heads To Become Lose

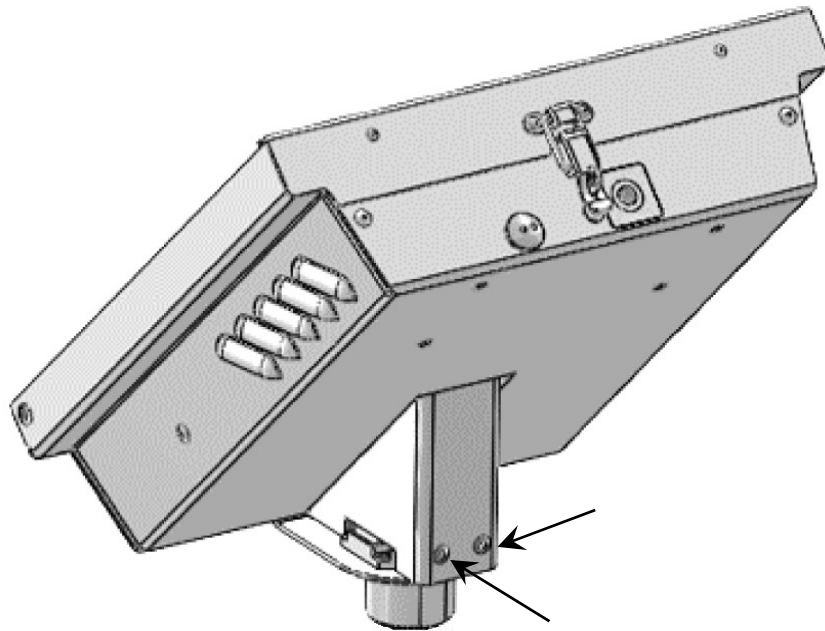
Pole impacts from snow removal equipment or errant vehicles can cause the, at the top of a 12-14 foot, the control unit to whip, damaging the neck rivets.

An easy test to see if this is the case, after an incident or as a test during the monthly inspection, grab the pole and shake it while observing the head.

If there is some movement of the head, track it over time. If it get worse consider replacing the rivets. These may have become stretched from impact(s).

If there is a lot of movement, check the neck rivets. These are either stretched beyond use or have been sheered off from a major impact. These rivets are not designed to withstand the stress from impacts these poles see. There is an easy repair for this.

You will need access to the head; either ladder, boom truck or take the unit down to do the repairs as needed. In the cases I have done I used a 1/4" x 3/4" self-drilling hex washer screw. Screws fit perfectly in drill chuck jaws.

With old rivet parts removed, screw secured in the drill chuck jaws, press the self-drilling drill point into the open rivet hole, press and use drill to send the screw home. The head will once more be secured.
