JIMSA[®]

HOW WOULD YOU ADDRESS THIS? MINI PIN CONNECTION

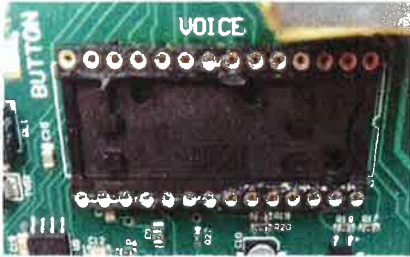
While mapping hardware components for traffic/pedestrian control devices, a tiny pin on an adapter was bent. Trying carefully to bend it back in place, it broke off. Just one little pin. The adapter is needed to allow the Voice Chip card to be connected to the main control board. The adapter was put back in place, the voice card for the RA-5 was installed – nothing! No location sound, no warning for crossing, only the amber lights would work. Okay, this pin was important.

Fig 1: On board socket of missing pin.

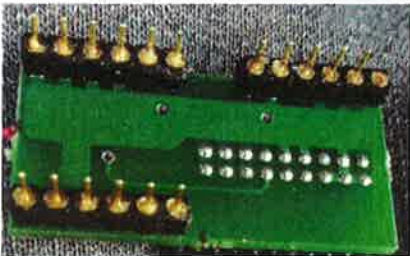
Fig 2: Back of adapter, missing pin

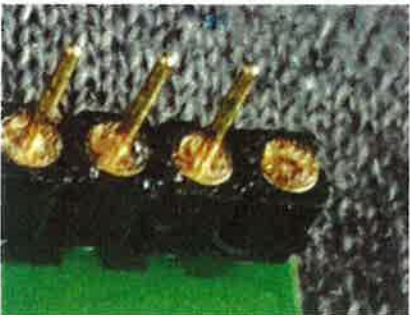
Fig 3: Close up of missing pin.

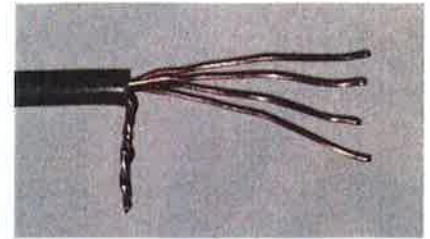
Fig 4: Bell Wire soldered to build a new pin

stripped. Two copper conductor wires were twisted then compared to the remaining pins on the adapter. Too thin, three was the magic number. The three were twisted, dipped in solder paste then tinned. The end of the newly made pin was trimmed to square the tip.

Solder paste was applied to the small copper/brass dome where the pin broke off the back of the adapter. With the aid of a

good magnifying glass equipped with LED light the assembly started. The newly built pin, held by the remaining insulated wire was positioned so the new pin aligned with the remaining pins and was centered on its dome. Soldering iron was cleaned, tinned, then a short period of heat was applied to the pin, not the dome. Didn't want any unnecessary heat near the adapter. Applying heat to the mid pin provided enough heat to allow the pin tinned earlier to solder to the dome. While still holding the insulated wire portion, lightly lifting, it holds good. We've created a new pin. The new pin length was trimmed just a shade longer than the remaining pins.

Back at the RA-5, an adapter with a newly built pin was installed into the onboard socket in the control card. Voice Chip Card installed into the adapter; system energized. There is now a Locator Sound. The PBS for the RA-5 was pressed... "Amber Lights Are Activated, Use Caution Crossing Street, Traffic May Not Stop", wow we're back up and running. Ran a full series of tests on the RA-5 system, everything has returned. Public Relations was contacted, the public was notified this RA-5 was back up and in full function. Start to finish was approximately 2 hours.
