Inoperable or Sticky button

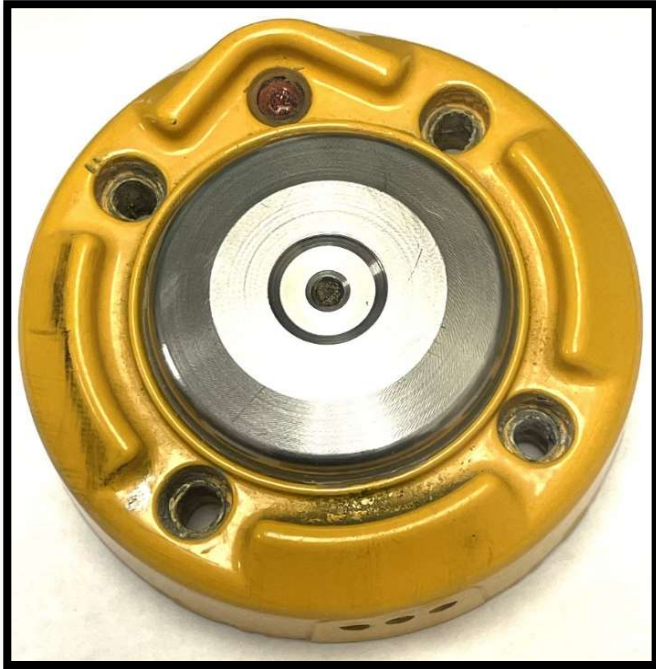
Have you experienced either a button not working or seemingly stuck on? Resident calls about a crossing

with a button not activating the crossing - only to get there and you have no problem using the button, activating the system as expected. Or resident or staff calling to let you know a crossing is in over / extended flash.

These are no doubt to the rugged construction of these units. But on occasion I receive calls as mentioned above, seemingly only during the winter months. It got me thinking, what if moisture is getting in some how and freezing. Both incidents mentioned can be accounted for - moisture freezing behind the silver dome preventing enough movement to

allow the button to activate the system. Or frozen moisture is preventing the domes release, placing an extended call on the system - also causing periodic beeping. How is this happening?

Thinking these might be frozen, I tried a micro-torch, gently heat the silver dome. Almost as soon as I started, there is an accumulation of moisture on the face of the silver dome. Continuing to heat evenly until this moisture is gone, the button returns to normal operations.
